Geocellular-Stabilized Covers over Geomembranes

Daniel F Senf, P.E., CPESC – *International Business Development Manager, Presto Geosystems*

Bill Handlos, P.E., CPESC – *Director, Presto Geosystems*

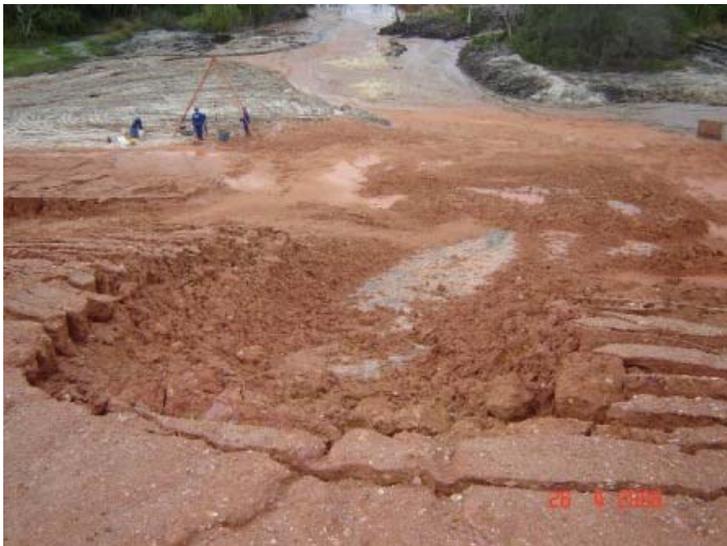
In this region of Brazil, the rainy season starts in April and typically lasts to September. Heavy rain may also occur in other months. In mid-June 2006, after a heavy rainfall, the soil cover on the 3H:1V slope failed at the geotextile-geomembrane interface and a large volume of soil slid down the slope from crest to toe. Furthermore, at some locations along the slope-crest, the geotextile tore, exposing the geomembrane.

The failed original slope cover viewed from the crest of the slope down.

Contributing factors to the slope cover failure were (1) a relatively low, (however within acceptable norms), interface friction angle between the geotextile and the textured geomembrane, (2) increased load from the saturated soil, and (3) seepage forces due to water flow within the relatively thick soil cover layer. The failure

involved 1,200 m³ (12,900 ft³) of cover soil and 1,800 m² (19,400 ft²) of geotextile. Although the geomembrane was not yet affected by the tear in the geotextile, a repair was urgently needed to prevent damage.

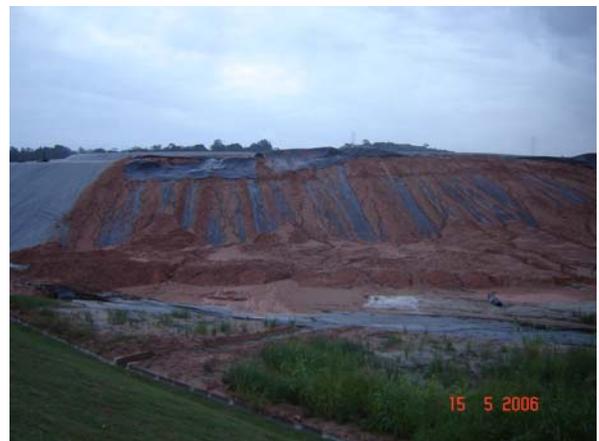
Damaged geotextile resulting from slope failure.

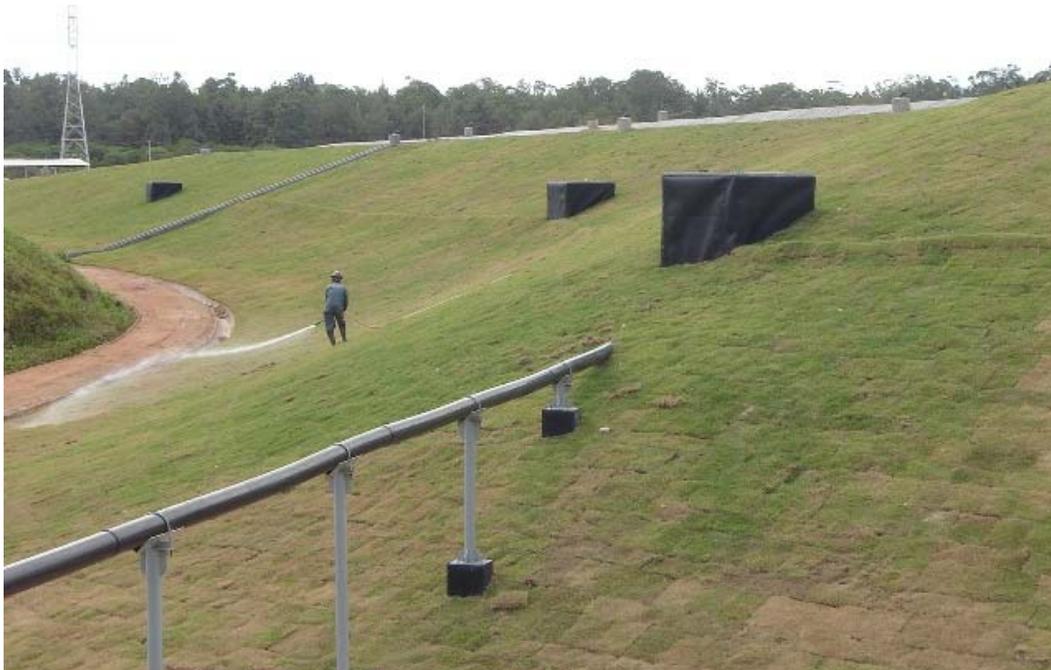
Construction work took place from October to December of 2006. The system has been through the 2007 and 2008 rainy season and has performed exceptionally.

Completed vegetated cover solution.
