GEOWEB®

Retaining Walls

Repair Eroded Channel Embankment

REPAIR OF ERODED HISTORIC BRIDGE EMBANKMENT

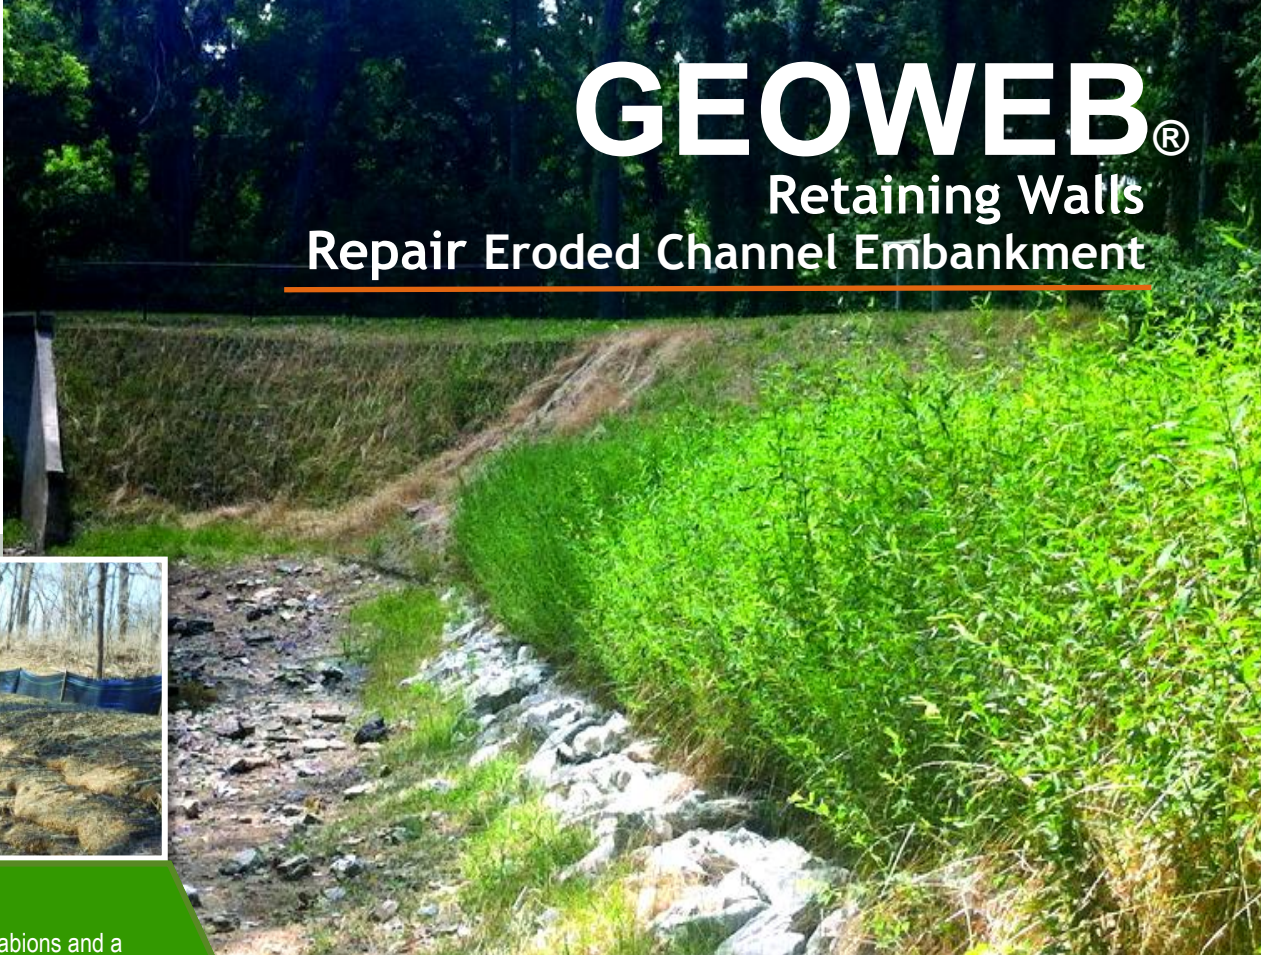
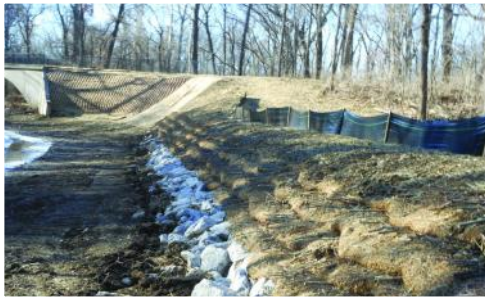
A GEOWEB® Retaining Wall, gabions and a geogrid reinforced coir mat system immediately after installation and with full vegetation.

HDR Engineering, working with local geosynthetic supplier ASP Enterprises and Presto Geosystems, designed a solution consisting of three reinforced wall systems including gabions for toe protection, a GEOWEB reinforced wall, and a geogrid reinforced coir mat "burrito wall" with live stake plantings. During construction, the creek's rock bottom could not be found. The contractor, Cobra Contractors, solved the problem by placing additional gabions at the base. Both the GEOWEB and geogrid "burrito wall" systems were quickly completed in time to install vegetation and live stake plantings to fully benefit from Spring rains. The fitness trail was reopened and the public way was restored.

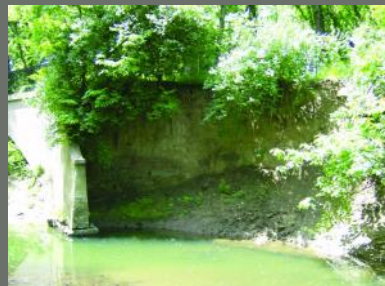
A popular and busy fitness trail along a stormwater channel was closed as a result of severe erosion. Intense urban runoff and highly erodible loess laden soils lining the banks combined to create the problem that intensified at the bridge abutment.

Abutment preconstruction showing erosion and loss of the trail.

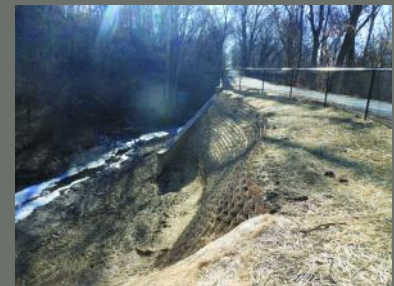
Completed GEOWEB wall section installed above a gabion base.
