GEOWEB®

RETAINING WALL ELIMINATES TRACK INSTABILITY; REDUCES MAINTENANCE
McKenzie, TN

GEOWEB® STABILIZATION SOLUTION EMPLOYED AT LONG-TERM RAILROAD EMBANKMENT PROBLEM AREA

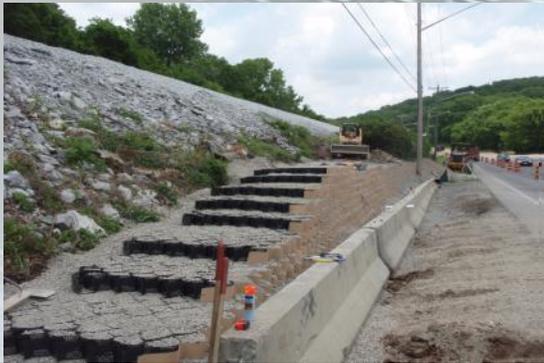
Top: Placing backfill in the Geoweb sections above the wall.

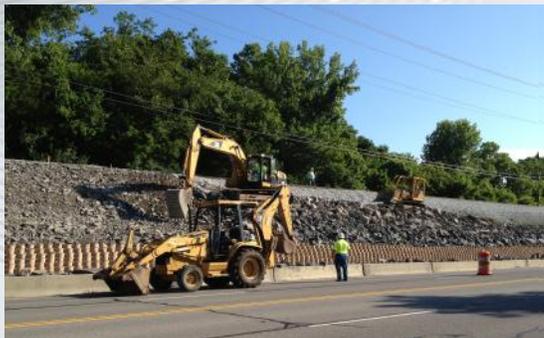
Bottom: Grading the slope above the wall.

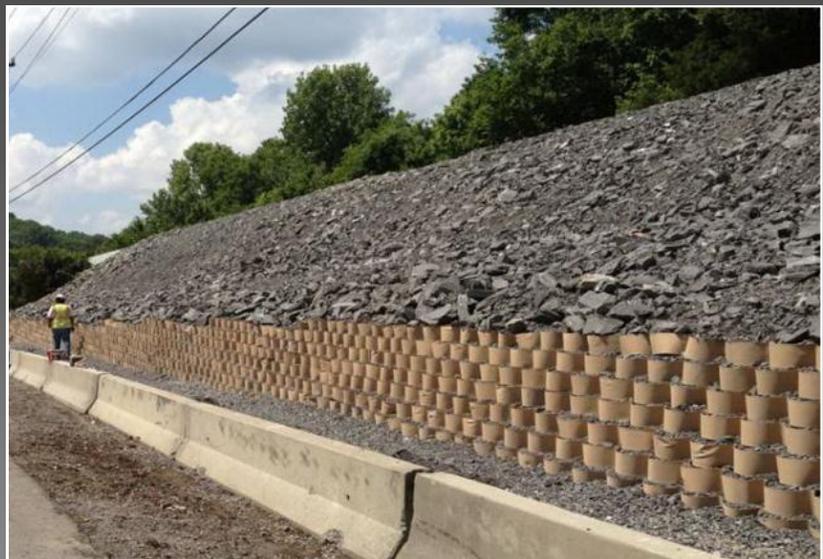
Completed GEOWEB retaining wall system with aggregate infill.

Work from track level to drive additional piling would be disruptive and would require significant site preparation work for equipment access. After considering several treatment methods, AMEC determined that a passive crib wall system along the toe utilizing the GEOWEB Earth Retention System was the preferred option. AMEC's decision was based on the GEOWEB system's ability to be constructed less expensively, and quicker than alternatives, with the added benefit of not disturbing train operations.

The GEOWEB system was selected as the MSE wall facing due to the system's light weight, flexibility during installation, tolerance to settlement, and ability to minimize downtime.
