GFR

Weatherizing steep slopes with geocells

A permeable geocellular system reinforces a deteriorating slope, preserving a railroad line.

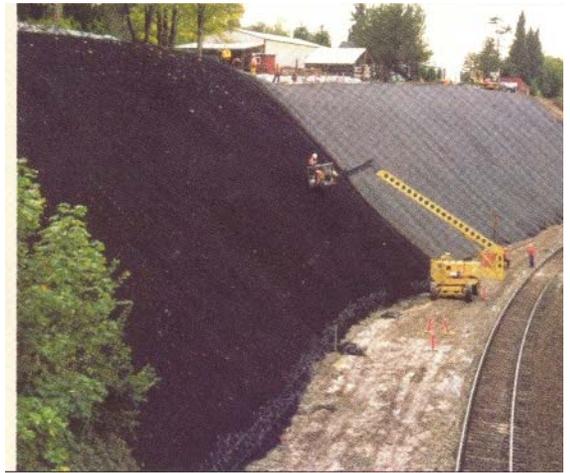
Photo 1. Prior to the installation of the geocellular system, heavy storms had caused landslides that blocked rail traffic for five days.

The idea is to prevent the kind of landslides that occurred at this site near Castle Rock, Wash., on the railroad's busy double-track mainline between Portland, Ore., and Seattle, Wash., in February 1996. That winter, after record precipitation, the saturated soils gave way, burying the tracks under 1.5 to 3 m (5 to 10 ft.) of mud and another 1.5 to 3 m of tangled, uprooted trees. The landslides blocked heavy freight and passenger traffic for five days.

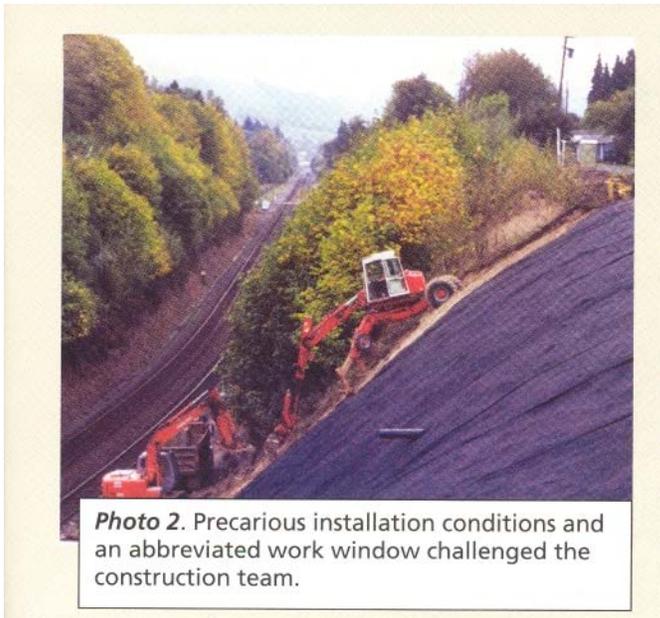
Photo 2. Precarious installation conditions and an abbreviated work window challenged the construction team.

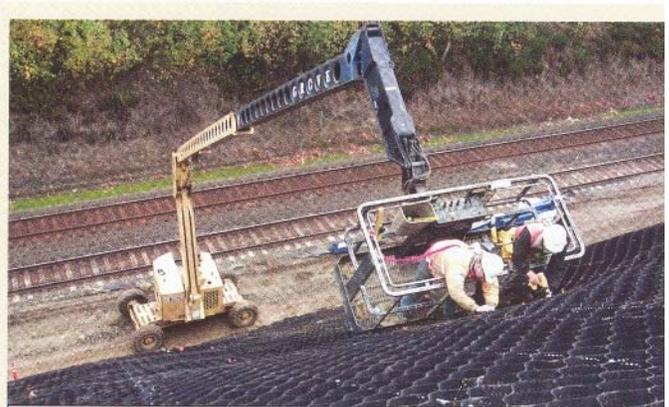
Photo 3. Following close upon the excavation crew's work, the installation team placed geotextile on the prepared slope face.

The geotechnical engineer chose to place the geocell system on top of a 7-oz./yd.² non-woven geotextile to reduce erosion and rilling of soils below the geocell by water flowing through or beneath the geocell and infill material, permit infiltration during typical rainfall, and encourage runoff during intense storm events. While a geomembrane would have prevented any water from soaking into the ground and adding to the weathering problem, it would have required more expensive methods to anchor the geocell system and was less cost-effective than the geotextile. Plus, benefits offered by a geomembrane would be offset by the ability of the geotextile-geocell system to permit water to infiltrate the slope and avoid groundwater pressure buildup.

The first step was to smooth the slopes for the geotextile by removing vegetation and loose soil. Depressions left by uprooted trees were shaped - no easy task considering the height and steepness of the slopes. Access restrictions at the top and bottom of the slopes, train traffic considerations, and soft,
