# Composite protection for slopes

*Geocells, geotextiles and geomembranes*

*resolve the chronic erosion problems of a municipal levee.*

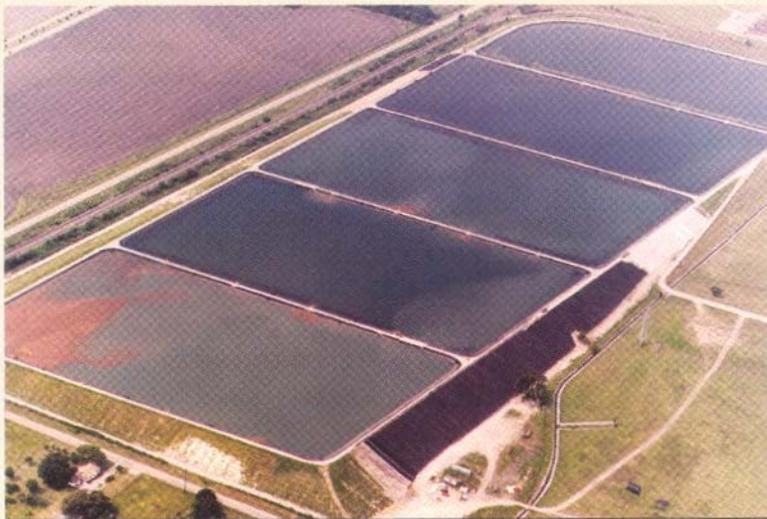
**Photo 1.** Prior to the installation of geosynthetics, the levee was plagued by erosion.

Because of the expansive nature of the levee embankment soils, the slope surfaces suffered from severe shrinkage cracking during the dry summer months. Water entered these cracks during the rainy season and found pathways into the deeper soil layers, creating instability in the slope structure.

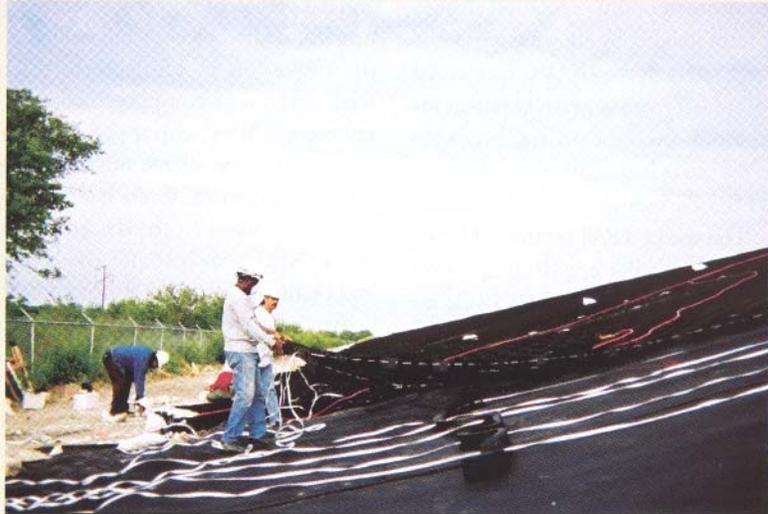
**Photo 2.** Installation of the geocellular system over geotextile and geomembrane.

A deadman anchor system—4 in. schedule 40 PVC pipe—was installed in the trench at the top of the slope and then the perforated geocell system sections were placed. Heavy-duty TP-91 tendons were run through the pre-drilled 4 in. cells and secured by wrapping and tying to the deadman anchor. The use of ATRA® restraint clips spread the working load of the gravel infill from the geocells to the tendons.

The large cell size enabled Colorado Lining International's installation team to work efficiently on the 3:1 slope face—running tendons, expanding, orienting and then securing the sections.

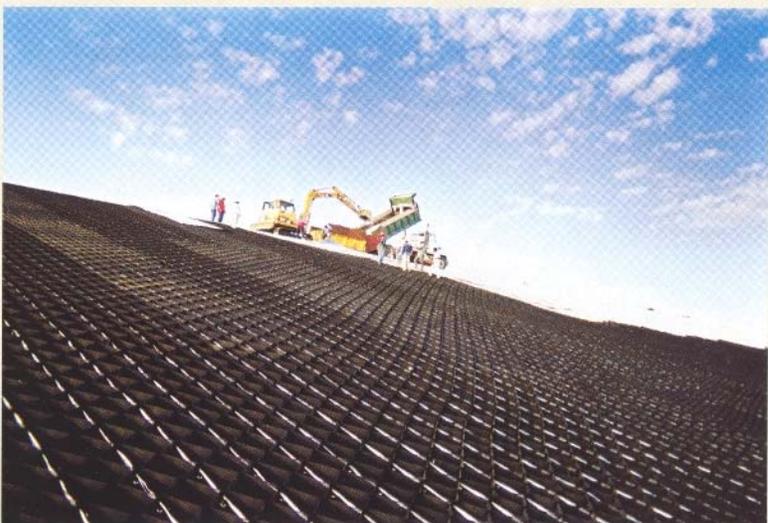
**Photo 3.** The slope during its final stage: aggregate is unloaded and raked into the cells.

a final cover for the protected slope. The aggregate contractor, AAA Sand & Stone Inc., designed a conveyor system to efficiently deliver materials to the slope. Upon delivery, a labor crew using long handled rakes spread the materials evenly in the cells. In all, 1,500,000 ft.<sup>2</sup> of geosynthetic products were installed, tested and back-filled on this project. The installation began in late August 2002 and was completed in early November.
