# GEOWEB®

## Vegetated Retaining Wall ROADWAY RUNOFF EROSION CONTROL

### VIRGINIA CANYON Clear Creek County Dumont, CO

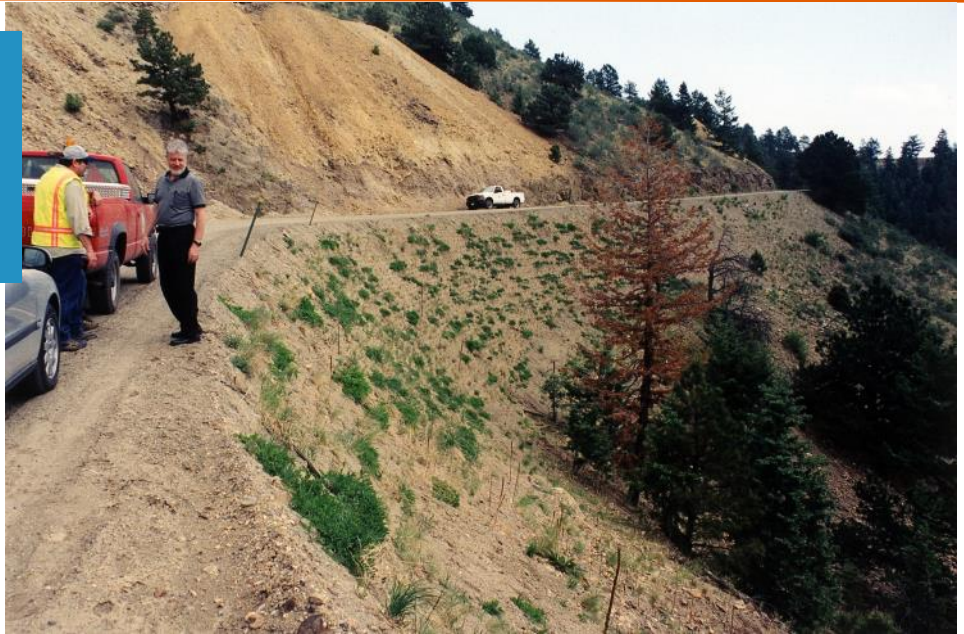
Tan material forms the front fascia of the near-vertical GEOWEB retaining wall to blend with local soil and arid conditions.

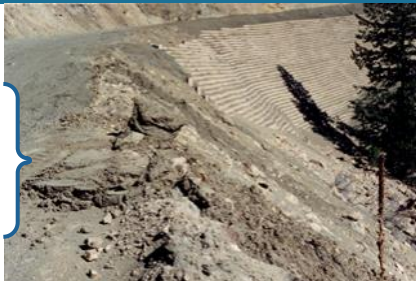
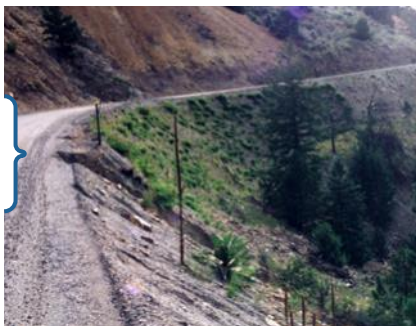
Volunteer vegetation established on the stable embankment.
