GEOPAVE®

PERMEABLE AGGREGATE ROAD SHOULDERS

North Barrington, Illinois

Permeable Pavers
Stabilize Shoulders,
Mitigate Water Issues

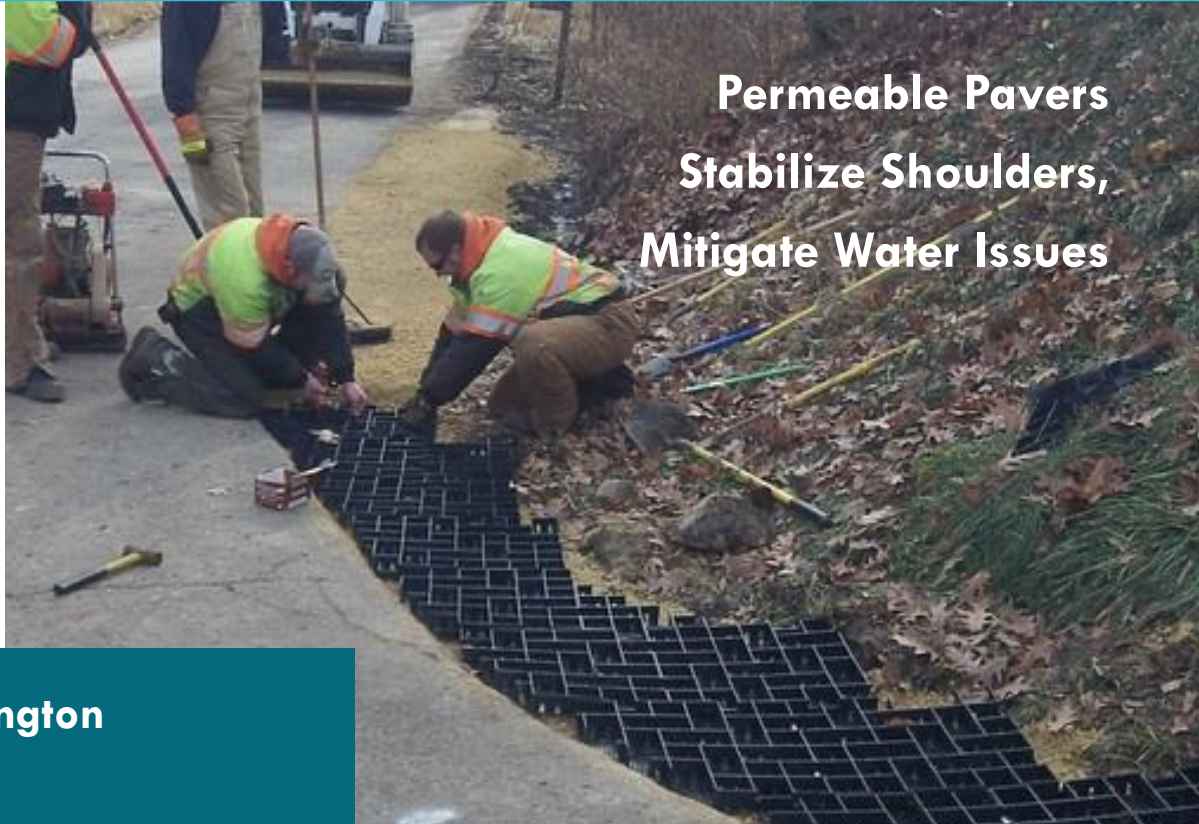
1 & 2) Connected GEOPAVE units along the road edge. Cut and staggered units accommodated a 20 ft. radius curve on the site.
3 & 4) Infilling the Geopave units with roadbase gravel over a 6-inch depth rock base.

Excessive sheet flow runoff down a narrow hilly section of roadway caused concern of sediment washout into a nearby restored watershed/creek. In freezing conditions, the sheet flow runoff posed dangerous ice conditions on blind sections of the roadway. In addition, due to North Barrington's narrow pavement and lack of road shoulders, road edges easily became rutted and collected standing water. This standing water further made road shoulders unstable and reduced load support for vehicles.

The permeable GEOPAVE® System not only provided positive drainage away from the road, but also created a stable driving shoulder suitable for supporting vehicle loads even during heavy rain events.
