Dike And Levee Upgrade/Repair

CASE STUDY

Sarnia, Ontario Tank Farm Retrofit

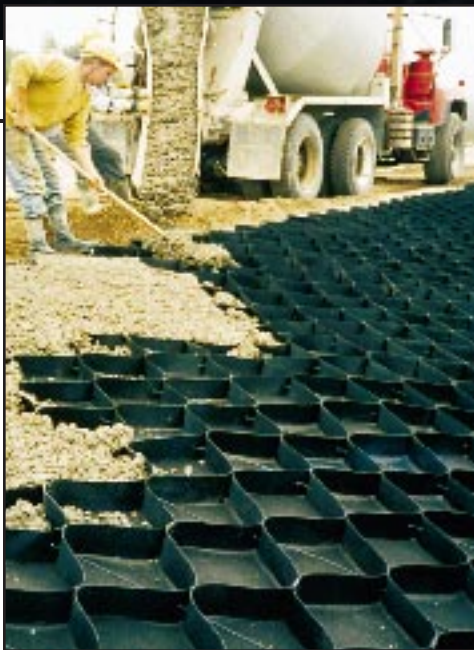
Application of concrete infill.

Although they were working on slopes with limited access, the crew placed 1,120 sq. meters (12,000 sq. ft.) of liner, geotextile, and unfilled Geoweb sections per day. A telescoping boom bucket excavator rapidly transferred 1,300 sq. meters (14,000 sq. ft.) of concrete per day into the system's cells. The Geoweb system's ability to conform to slope irregularities contributed to high productivity, a consistent measurable concrete thickness, and a quality finished system.

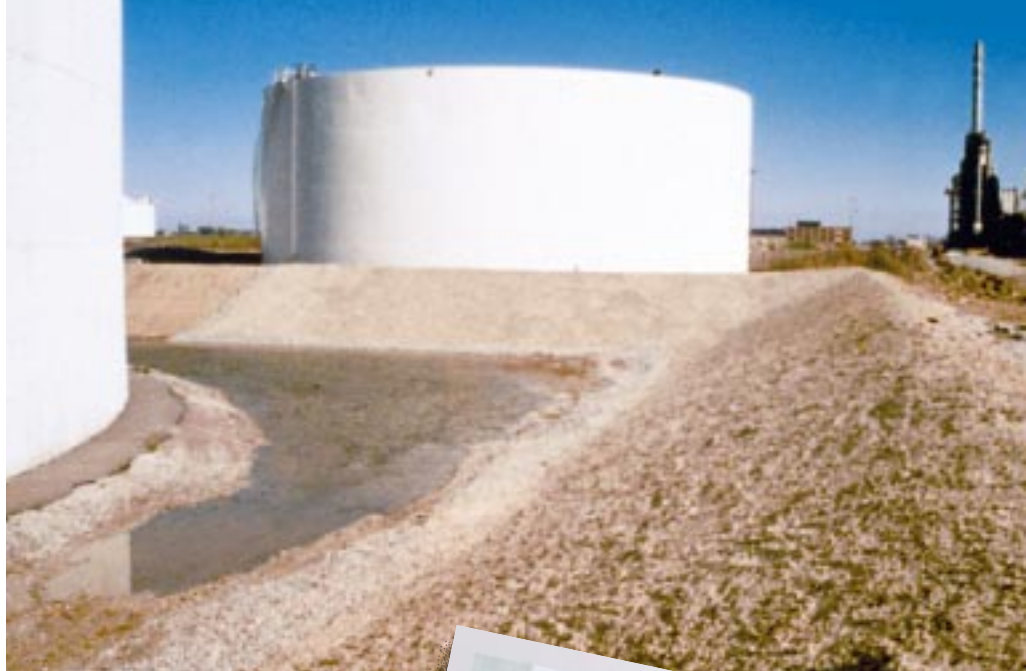
Completed concrete infilled Geoweb dike protection system.

The tank dike areas measure approximately 3,120 sq. meters (34,600 sq. ft.) per tank. Slopes were 2.5 h:1 v with a slope length of 7.9 meters (26 ft.). A polyethylene liner was placed directly over the slope surface, making the dikes impermeable. The liner was overlaid with layers of nonwoven geotextile to provide protection to the liner during the concrete pouring. A 6.6 cm (2.6 in.) deep Geoweb layer was placed over the geotextiles, filled with 14 MPa (2,000 psi) concrete, and finished flush with the top of the cells.

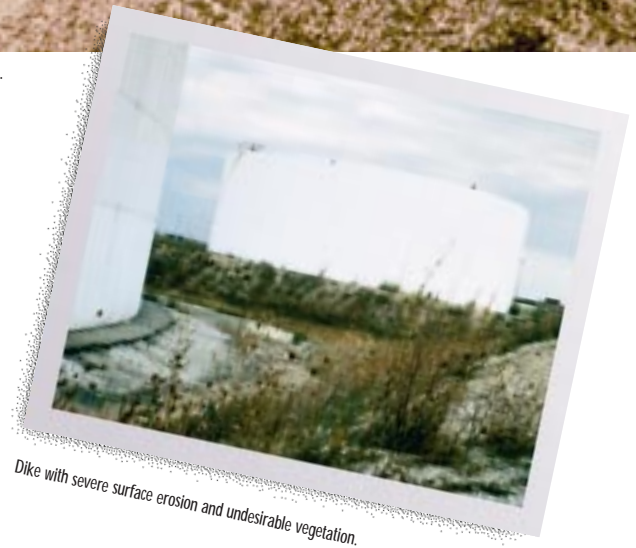
Dike with severe surface erosion and undesirable vegetation.

Economically upgrade and repair dikes that have suffered from severe surface erosion and growth of undesirable vegetation.
